Re: Colfax Creosoting Company - Pineville, LA
RIN: 06-RIN-00279-09

RCRA INSPECTION

To: David Wineman, Region VI RPO
Thru: ^{FOR} K. H. Malone, Jr., FITOM *get*
Thru: I. Sekelyhidi *RW*
From: Raymond Wayne, FIT Ground Water Hydrologist
Date: June 8, 1988
Subj: RCRA Facility Assessment at the Colfax Creosoting Company,
Pineville, LA (LAD008184616)
TDD# FO6-8709-35
PAN# FLA0239CAA

Figure 1. Approximate Locations Of Observed Substances In The Surface Water Runoff Paths. SCALE: 1"=400'

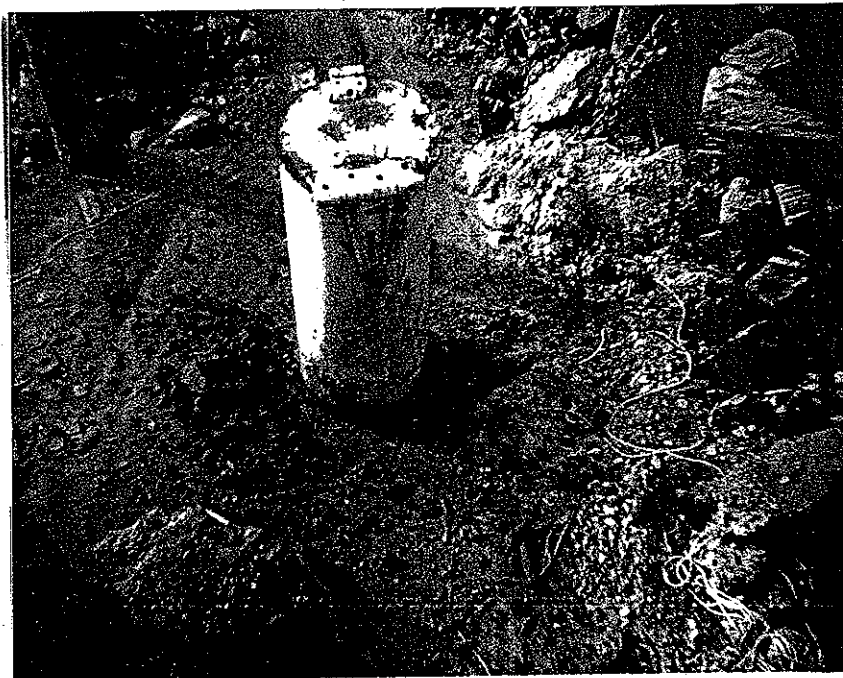
SUBJECT: monitoring well #3
close up
LOCATION: COLFAX CREOSOTING
LA D008 184616
CITY: Fireville COUNTY: — STATE: LA
DATE: 11/14/83 TIME: afternoon
WEATHER: (SUN) (HAZE) (CLOUDY) (RAIN) (SNOW)
PHOTOGRAPHER (Sig.) Holly Anderson
WITNESS: Tom Patterson - DNR
CAMERA: Kodak 110
FILM TYPE: — ASA: — T: 1/ — f: —
NEGATIVE LOCATION: — FILE #: —
PROCESSED BY: —
PHOTO #: 4 of 15

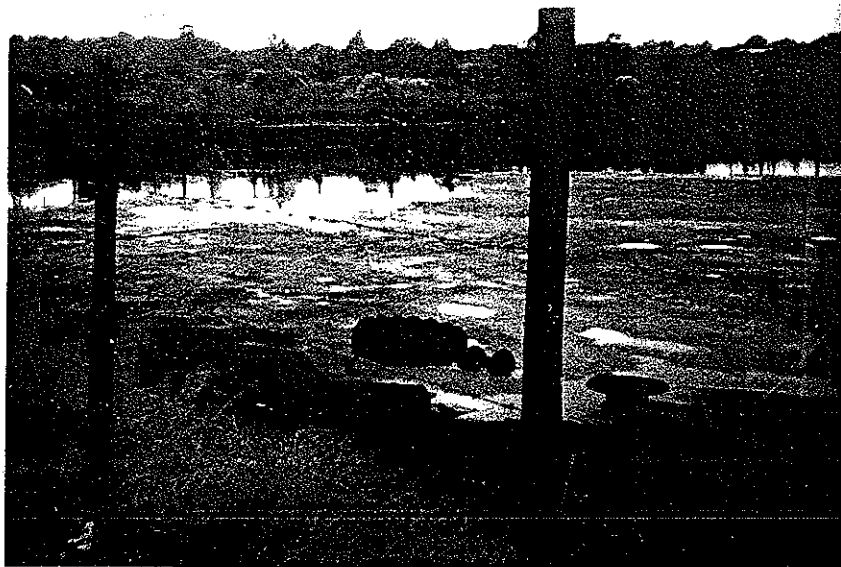
SUBJECT: impoundment
LOCATION: COLFAX CREOSOTING
LA D008 184616
CITY: Fireville COUNTY: — STATE: LA
DATE: 11/14/83 TIME: afternoon
WEATHER: (SUN) (HAZE) (CLOUDY) (RAIN) (SNOW)
PHOTOGRAPHER (Sig.) Holly Anderson
WITNESS: Tom Patterson - DNR
CAMERA: Kodak 110
FILM TYPE: — ASA: — T: 1/ — f: —
NEGATIVE LOCATION: — FILE #: —
PROCESSED BY: —
PHOTO #: 6 of 15

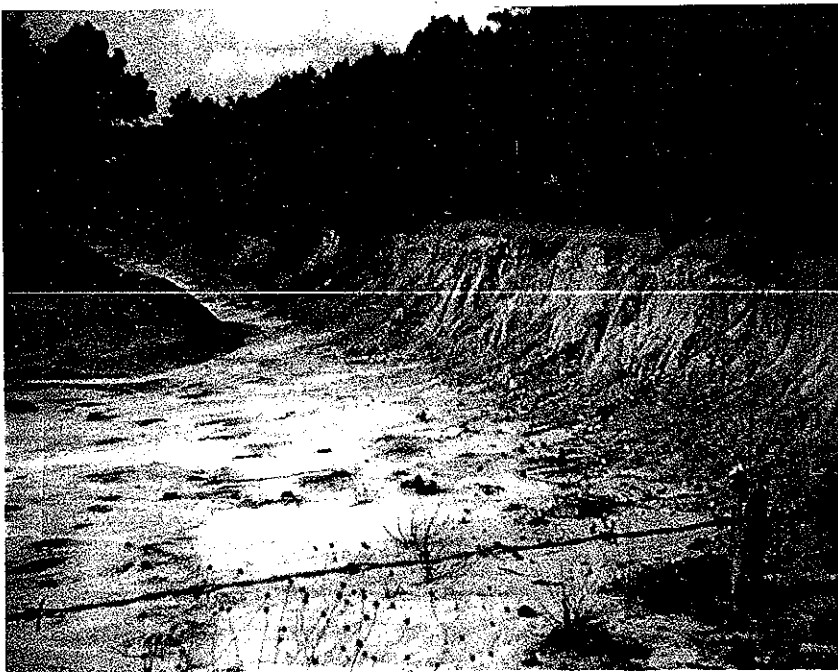
SUBJECT: impoundment
LOCATION: COLFAX CREOSOTING
LAD 008184616
CITY: Pineville COUNTY: STATE: LA
DATE: 11/14/83 TIME: afternoon
WEATHER: (SUN) (HAZE) (CLOUDY) (RAIN) (SNOW)
PHOTOGRAPHER (Sig.) Holly Anderson
WITNESS: Tom Patterson - DNR
CAMERA: Kodak 110
FILM TYPE: ASA: T: 1/ f:
NEGATIVE LOCATION: FILE #:
PROCESSED BY:
PHOTO #: 9 of 15

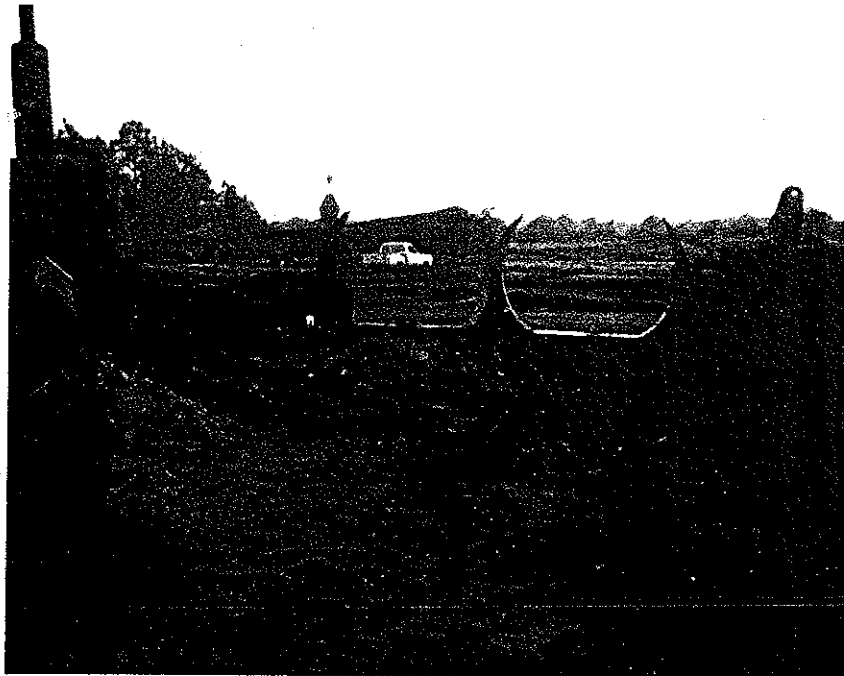
SUBJECT: impoundment - break
in fence
LOCATION: COLFAX CREOSOTING
LA D008184616
CITY: Pineville COUNTY: STATE: LA
DATE: 11/14/83 TIME: afternoon
WEATHER: (SUN) [HAZE] [CLOUDY] [RAIN] [SNOW]
PHOTOGRAPHER (Sig.) Holly Anderson
WITNESS: Tom Patterson - DNR
CAMERA: Kodak 110
FILM TYPE: ASA: T: 1/ f:
NEGATIVE LOCATION: FILE #:
PROCESSED BY:
PHOTO #: 12 of 15
